ICPI TECH SPEC

NUMBER • 7

Repair of Utility Cuts Using Interlocking Concrete Pavers

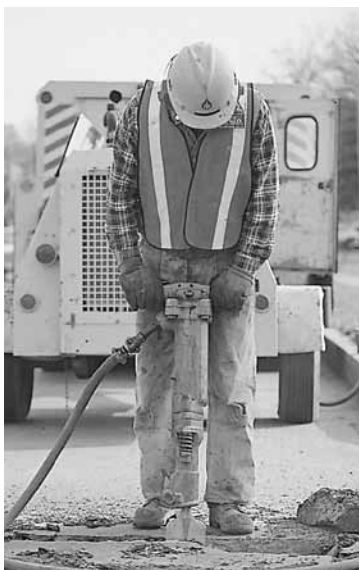
Figure 1. Repairs to utilities are a common sight in cities, incurring costs to cities and taxpayers.

North American cities have thousands of utility cuts made in their streets each year. Figure 1 shows a daily occurrence in most cities: repairs to underground utility lines for water, sewer, gas, electric, steam, phone, fiber-optic, or cable services. A sample is given below of the number of annual utility cuts in a few cities.

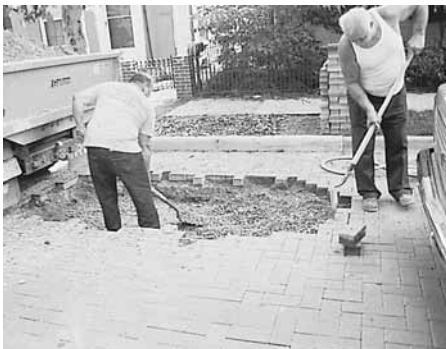
Figure 2. Removal of concrete pavers for a gas line repair in Dayton, Ohio.

Figures 2, 3, 4, 5 and 6 show the process of repair and illustrate the continuity of the paver surface after it is completed. The reinstated units are knitted into existing ones through the interlocking paving pattern and sand filled joints. Besides providing a pavement surface without cuts, the joints distribute loads by shear transfer. The joints allow minor settlement in the pavers caused by discontinuities in the base or soil without cracking.

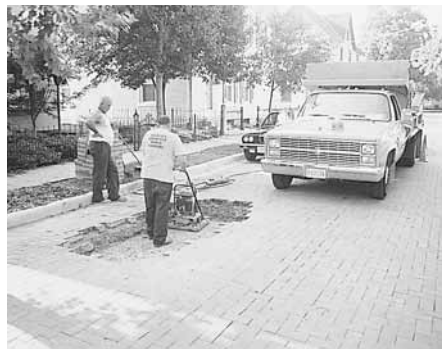
Figure 3. Compaction of the base.

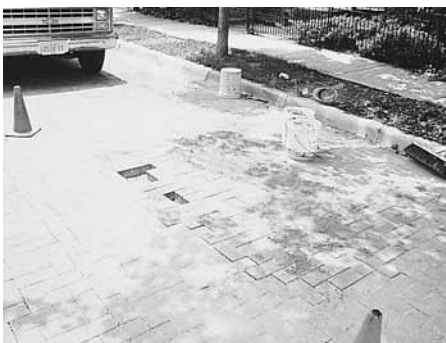
Figure 4. Reinstatement of the pavers, bedding and joint sand.

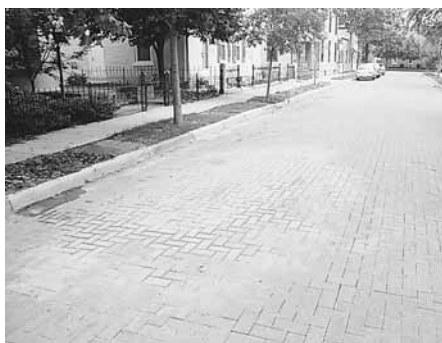
Figure 5. The final paver surface is continuous. There are no cuts or damage to the pavement.

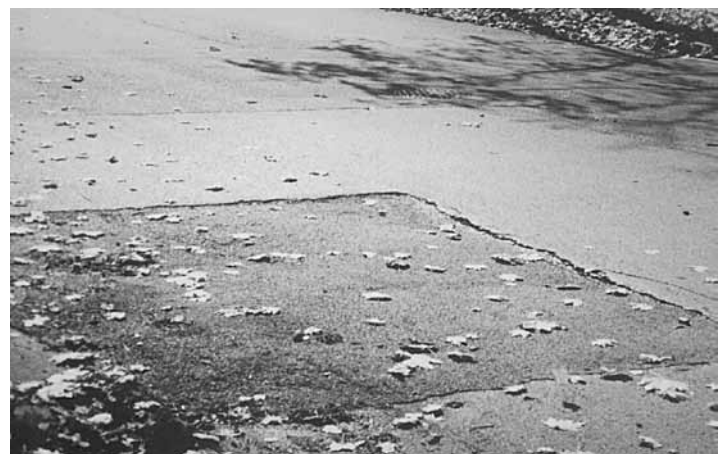
Figure 7. Pavement damage from settlement and shrinkage of cold patch asphalt.

Figure 7 shows the result of settlement and shrinkage of the cold patch asphalt in a London, Ontario, utility cut. The change in dimensions causes the edge of the cut asphalt to deteriorate, and settlement decreases riding quality.

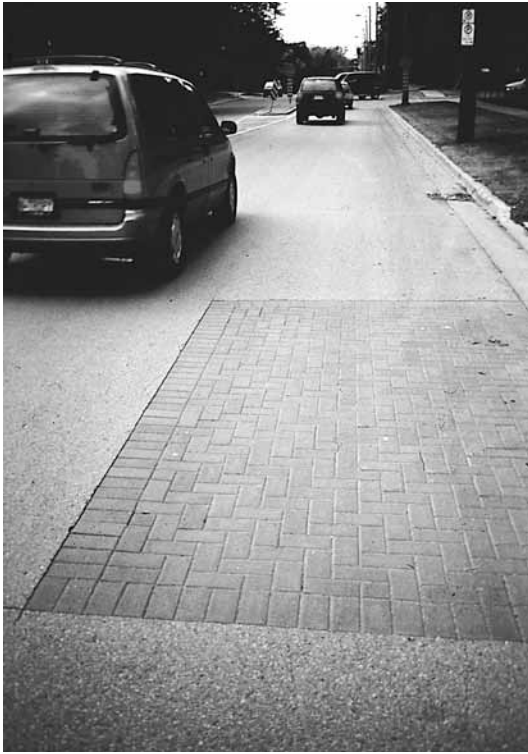
Figure 8. Utility cut repair in a residential area in London, Ontario.

Concrete pavers on low density concrete fill have been successfully used as a replacement for cold patch asphalt (Figures 8 and 9). They were first used as a temporary repair with the intent of being removed in the spring. However, the pavers performed so well that the City of London left them in place indefinitely. Several repairs were in streets subject to heavy truck traffic, as well as residential streets. Costs were less than using cold patch asphalt.

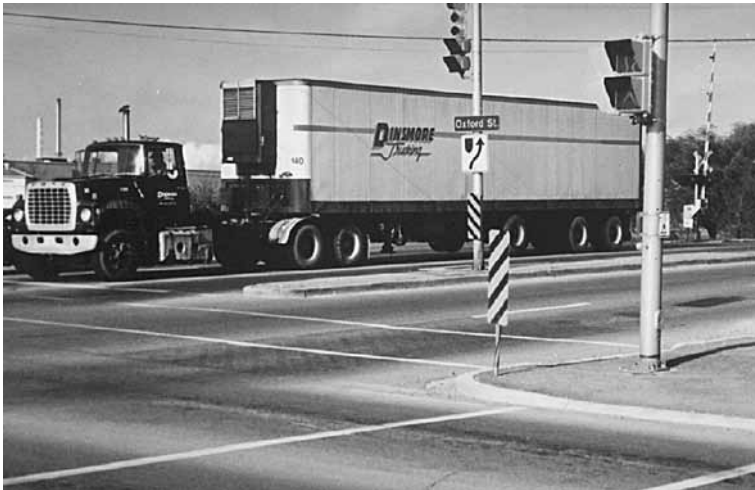
Figure 10. A patch of barely discernable pavers in a heavily trafficked intersection in London, Ontario.

quality and safety has improved to the extent that the transition from one surface to the next can barely be discerned by the driver. The pavers were colored to match the appearance of the asphalt so there would be no substantial differences in appearance. Figure 10 shows such a patch of pavers blending with the surrounding pavement.

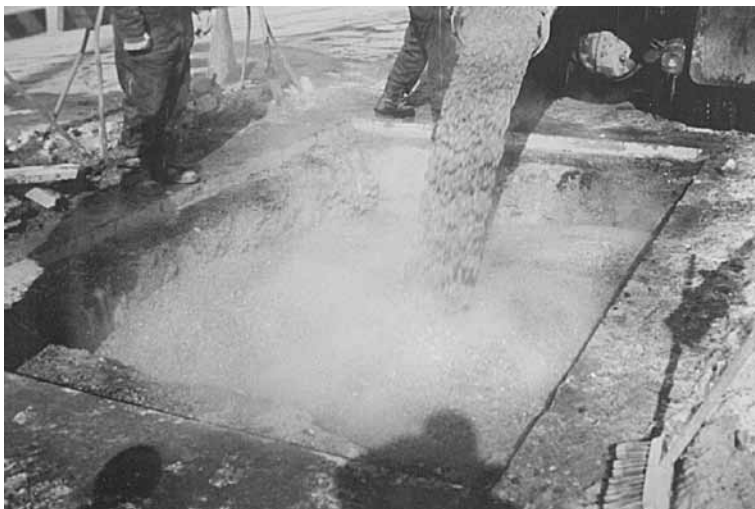
Figure 11. Low density concrete fill (unshrinkable fill) poured into a utility trench from a ready-mix concrete truck.

Unshrinkable fill poured into the trench is shown in Figure 11. The fill flows into undercuts, under the edge of the cut asphalt (providing additional support), and in places where the soil or base has fallen from the sides of the trench. These places are normally impossible to fill and compact with aggregate base

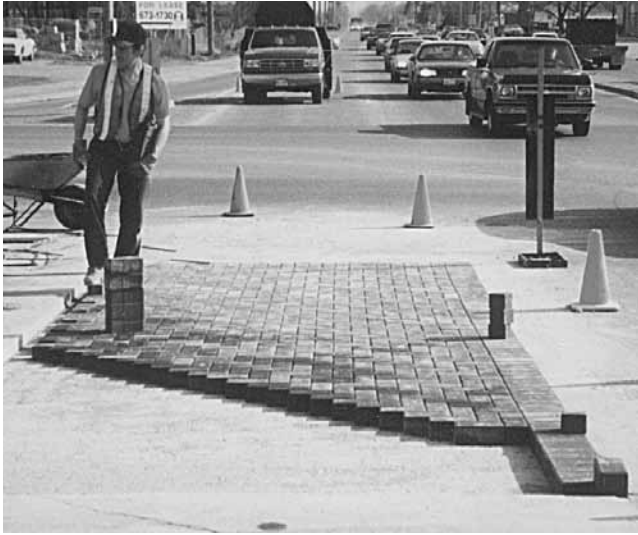
Figure 12. Pavers are laid in a 90 degree herringbone pattern between the border courses.

Place pavers between the border course in a 90 degree herringbone pattern (Figure 12). Joints between pavers should not exceed 1/16 in. (2 mm). Compact the pavers with a minimum 5,000 lbf (22 kN) plate compactor. Make at least two passes with the plate compactor. A small test area of pavers may need to be compacted to check the amount of settlement. The bedding sand thickness should be adjusted in thickness to yield pavers no higher than 1/8 in. (3 mm) above the edge of the asphalt.

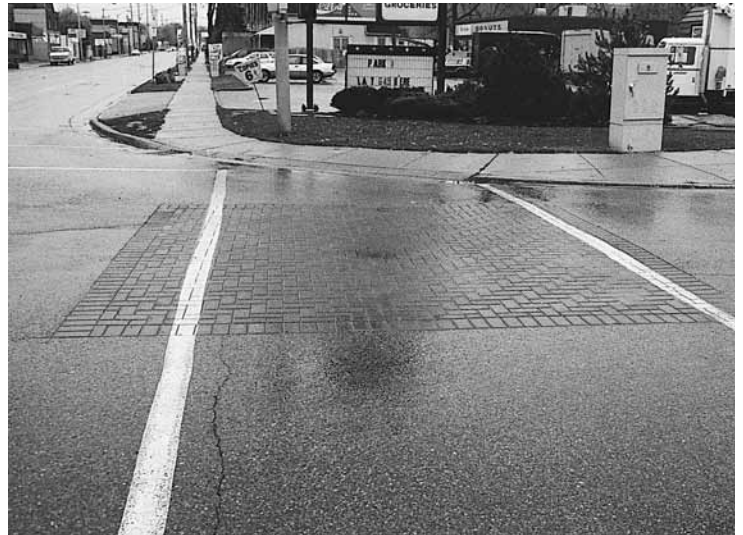
Figure 13. Concrete pavers in utility cuts can be painted as any other pavement.

ments of ASTM C 144 (11) or CSA A179 (10). The joints must be completely full of sand after compaction. Remove excess sand and other debris. The pavers may be painted with the same lane, traffic, or crosswalk markings as any other concrete pavements (Figure 13).
